Contract #: 04-0120F4

WELDING INSPECTION REPORT

OSM Arrival Time: 700 **Project Name:** SAS Superstructure **OSM Departure Time:** 1730 **Prime Contractor:** American Bridge/Fluor Enterprises, a JV

34-0006 **Bridge No: Component:** OBG

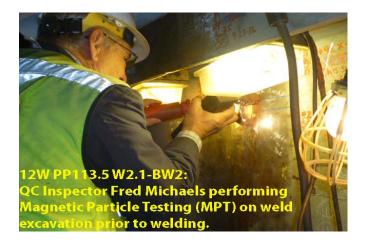
Welder was observed performing weld repairs on weld 12W PP113.5 W2.1-BW2. Welder was observed utilizing Caltrans approved Welding Procedure Specification's (WPS) ABF-WPS-D15-1000R Rev.2 for Shielded Metal Arc Welding (SMAW) to repair indications rejected by Ultrasonic Testing Shear Wave (UTSW). The welder was observed preheating the welds prior to Carbon Arc Gouging and welding. Other welding parameters as inspected by QC Inspector appear to be in compliance with the WPS noted above.

weld 12W PP114.5 W2.1-BW2. Welder was observed utilizing Caltrans approved Welding Procedure Specification's (WPS) ABF-WPS-D15-1000R Rev.2 for Shielded Metal Arc Welding (SMAW) to repair indications rejected by Ultrasonic Testing Shear Wave (UTSW).. The welder was observed preheating the welds prior to Carbon Arc Gouging and welding. Other welding parameters as inspected by QC Inspector appear to be in compliance with the WPS noted above.
